#### **FRT Protection Settings**

**Damian Jackman**

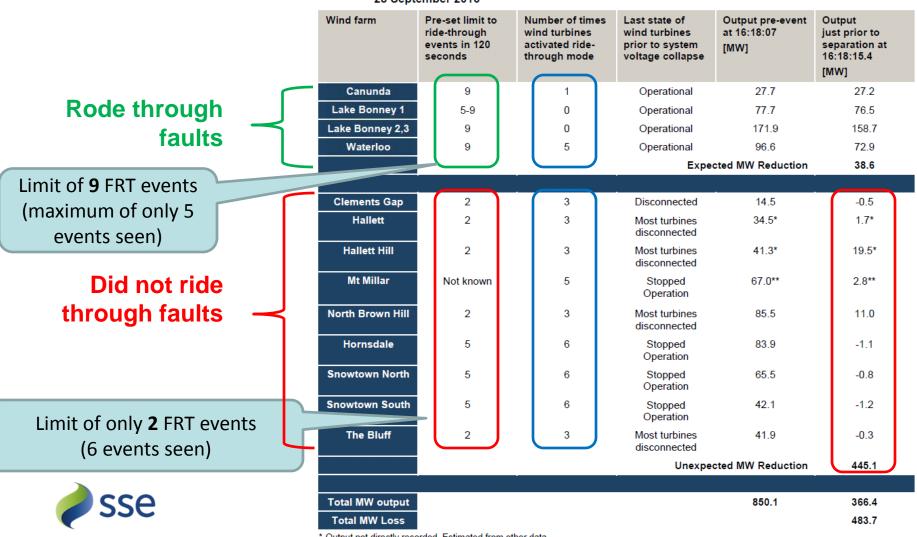
Table 4 SA wind farm responses to six voltage disturbances between 16:17:33 and 16:18:15 on 28 September 2016

Five system faults within 88s resulted in <u>six</u> voltage disturbances and a loss of 445 MW wind generation. The subsequent increase in load on Heywood interconnector resulted in an interconnector trip leading to a 900 MW

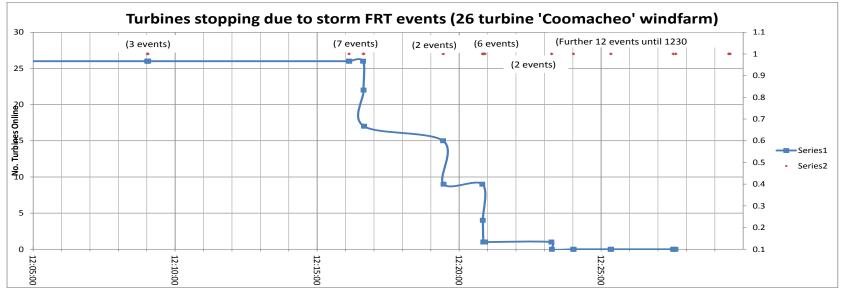
• Coomacheo Windfarm, 26 x 2.3 MW turbines, SW Ireland

- 33 FRT Events detected by wind turbines within period of ~ 25 min
- Events were clustered so <u>that several occurred within 1s but were still</u> <u>recorded by the wind turbines as separate events</u>
- All turbines were stopped within 5 minutes of first FRT event
